SUBJECT: Final Five-Year Review Report for the Former Sacramento Army Depot, Sacramento, California

A site inspection was conducted on August 18, 2017. The site inspection was conducted by the Army's consultant Westmark. The purpose of the inspection was to assess the protectiveness of the remedy, including the integrity of the CAMU's soil cover and access restricting fencing, adherence to land use restrictions that prevent groundwater use, and the condition of the groundwater treatment systems.

FIFTH FIVE-YEAR REVIEW REPORT FORMER SACRAMENTO ARMY DEPOT SACRAMENTO, CALIFORNIA

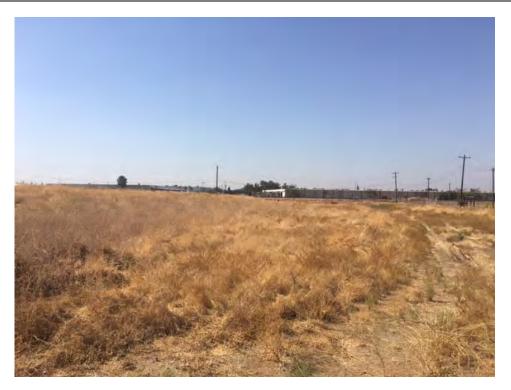
Corrective Action Management Unit (October 9, 2017)

No significant issues were identified regarding the CAMU's soil cap or the access restricting fencing. The ICs in-place include prohibitions on the use of groundwater until clean-up levels are achieved, disturbance of the soil cap, and any other activities or actions that may interfere with the implemented remedies. No activities were observed that violated the ICs. The soil cap and surrounding area were undisturbed, and no new uses of groundwater were observed. The groundwater treatment systems were observed to be in good condition. The Site Inspection Checklist and Site Photographs are presented in **Appendix G** and **Appendix H**, respectively.
